# Manhole Inspection Summary

Manhole # S35CC2012MH

Insp Date: **12/20/06 9:03 AM**

**Location** Address: **8 BRACKENRIDGE CT**

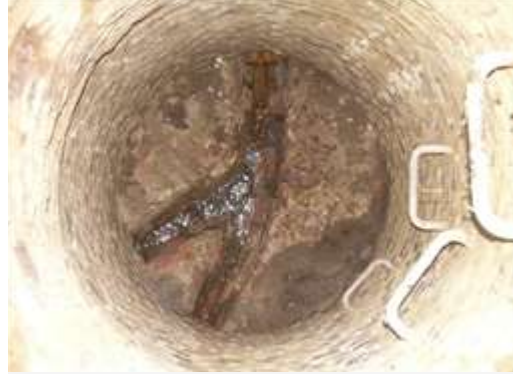
Top View

Bench debris.

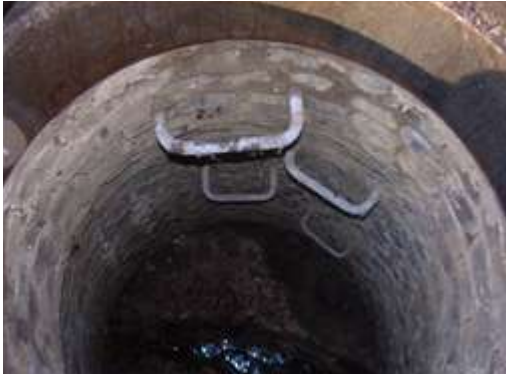
Defect

Adjustment deterioration and infiltration.  
Corbel and Barrel infiltration. - other side.

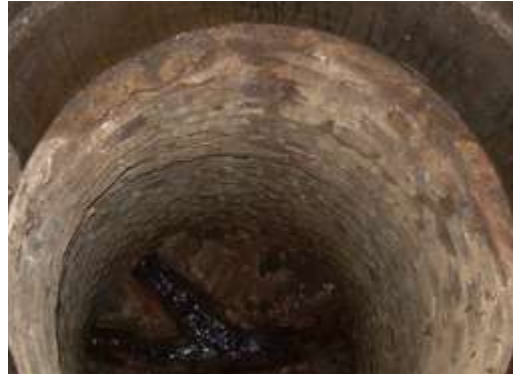
Defect

Frame offset. Adjustment deterioration  
and infiltration. Corbel and Barrel  
infiltration.

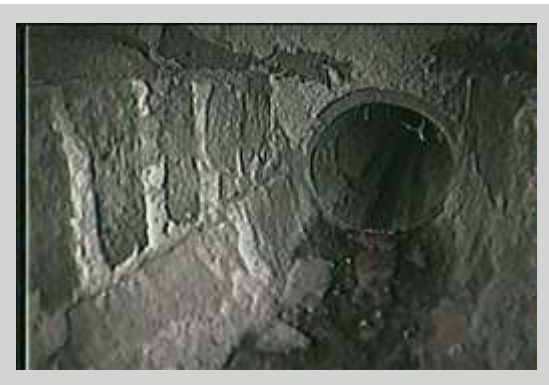
### 6 in. Circular Gravity Sewer Pipe In @ 7 O'Clock

Infiltration: **Evidence** Pipe Seal Cond: **Unknown**

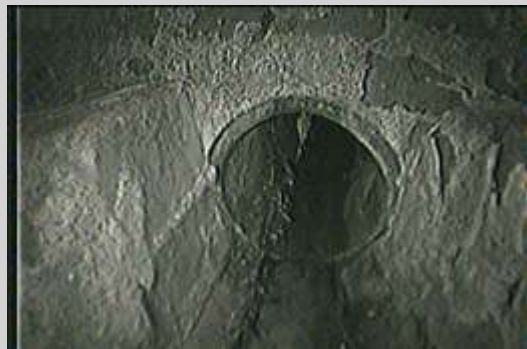
6 in. Circular Gravity Sewer

Infiltration: **Evidence**

Pipe Seal Cond: **Roots**
